February 23, 2018

1119.01

Re: Habitat Assessment for 2340 Harper Street, Santa Cruz, CA

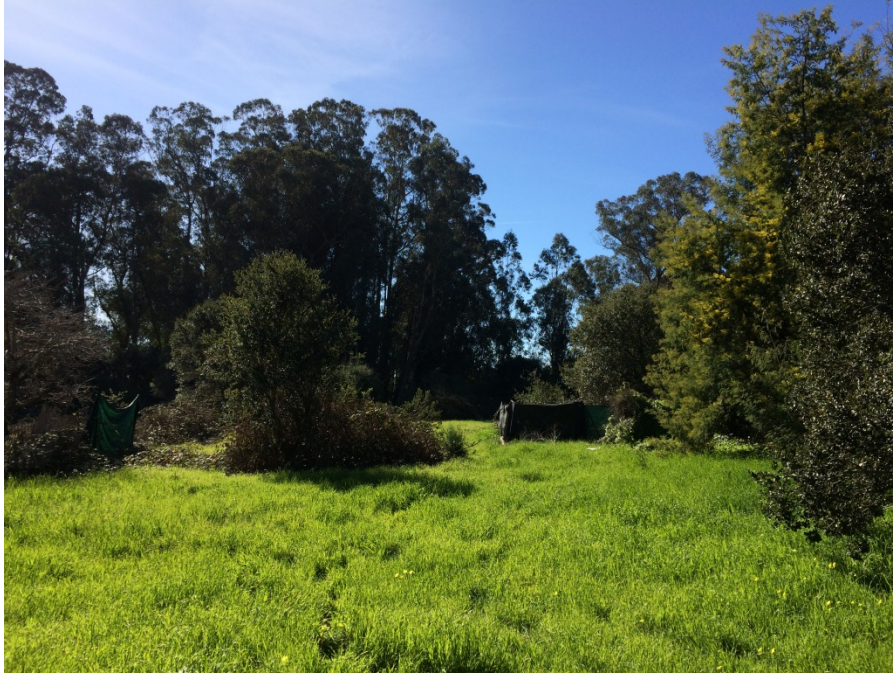
Photo 1. Proposed project location. Open field is mowed at least once annually. Small coast live oak trees are scattered throughout the yard. Eucalyptus trees next to drainage are visible at the back of the property. View south.

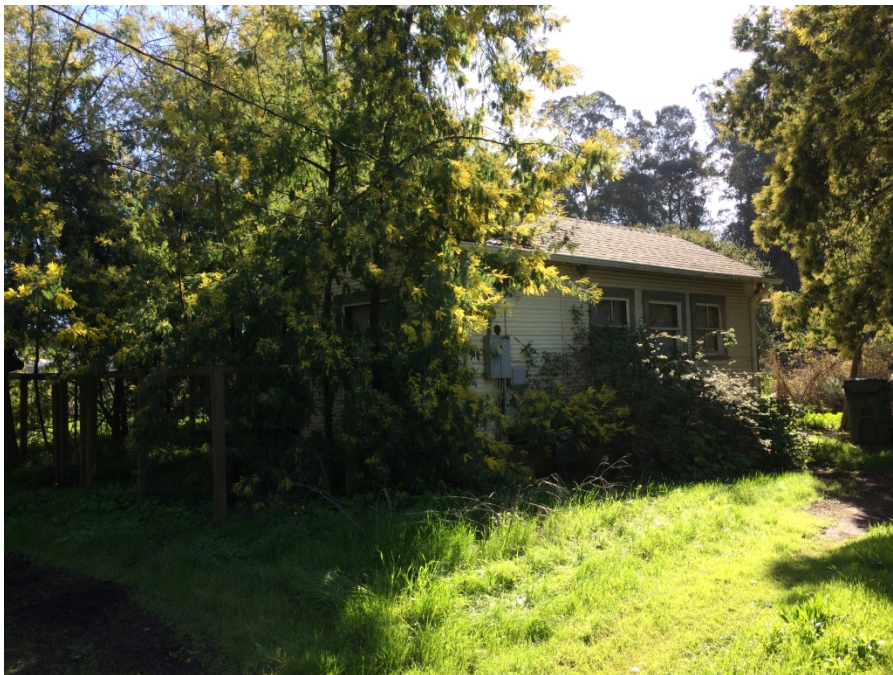
Photo 2. Single-story house that will be removed as part of the proposed project. The house is surrounded by non-native acacia trees. View southeast.

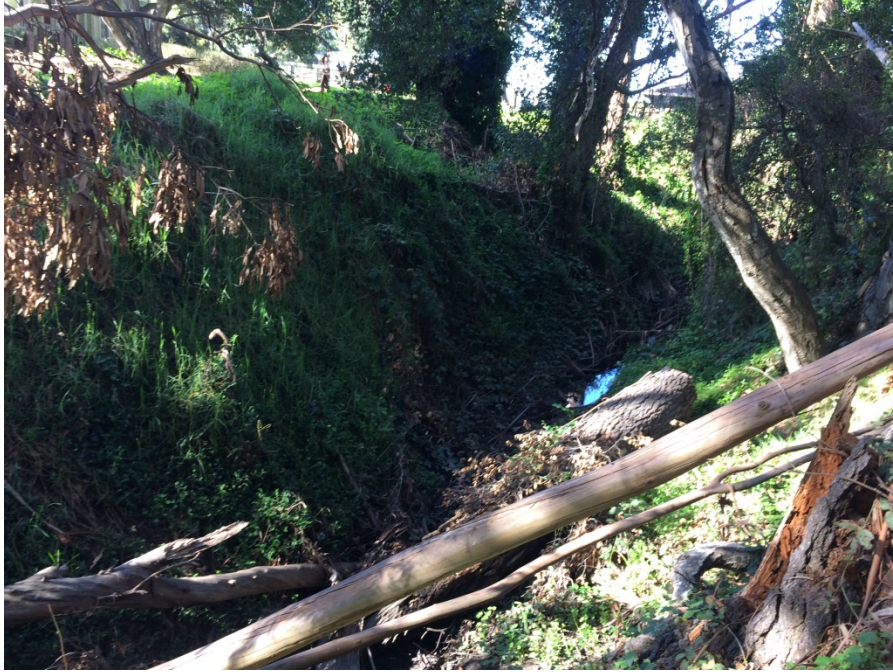
The drainage which forms the southern boundary of the property is bordered by woodland comprised of tall mature blue gum eucalyptus (*Eucalyptus globulus*) and smaller coast live oaks (*Quercus agrifolia*) approximately 10 to 15 feet tall. This eucalyptus-oak woodland covers the southern portion of the property. The woodland has a dense understory comprised primarily of non-native shrubs and forbs including cape ivy, English ivy (*Hedera helix*), and Himalayan blackberry. Native shrubs such as California blackberry (*Rubus ursinus*) and poison oak (*Toxicodendron diversilobum*) are present in patches. The drainage contained water a few inches deep in January 2018. Large amounts of woody debris, including entire downed eucalyptus trees, lay in the drainage, potentially blocking storm flows.

Photo 3. This drainage forms the southern boundary of the property. Water was present in the drainage. Note downed trees and other woody debris in channel. View west.

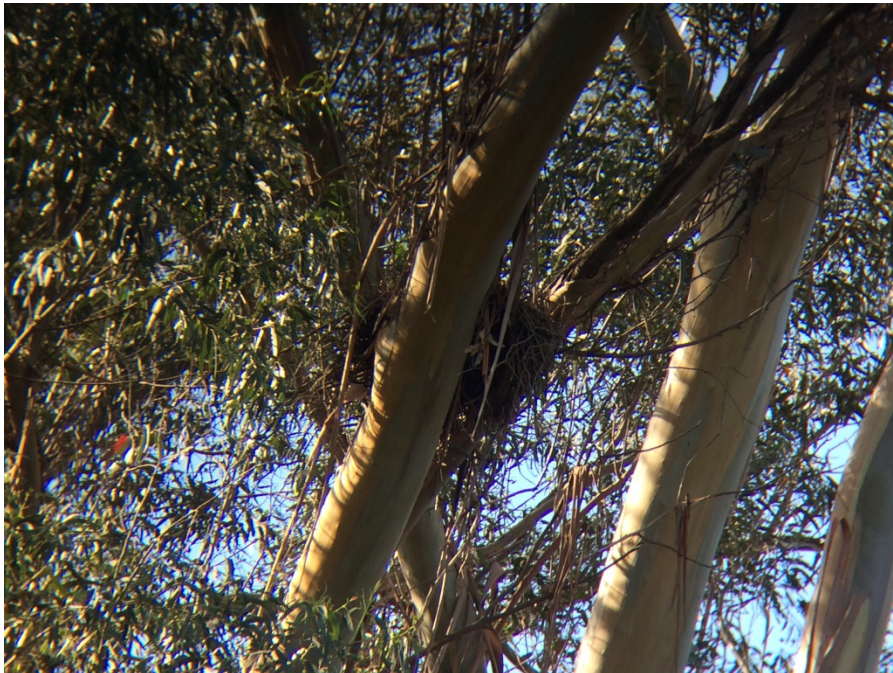
One potentially active bird nest was observed. A red-tailed hawk nest was present in a eucalyptus tree in the southwest corner of the property. One adult red-tailed hawk was perched in the tree near the nest. The nest will likely be active this season. According to a local resident, the hawks have nested in this location in previous years. Potential habitat for other nesting birds exists in trees, shrubs, and other structures on the property. Mitigation measures including nesting bird surveys and construction activity buffers should be used to avoid impacts to nesting birds.

Photo 4. Potentially active red-tailed hawk nest in a blue gum eucalyptus in the southwest corner of the property. One adult red-tailed hawk was observed perched near the nest. View southwest.

In order to avoid impacts to nesting birds, nesting bird surveys should be conducted in advance of any tree trimming, tree removal, or construction activities which take place during nesting season (February 15 through August 31). If nesting birds are located, active nests should be buffered from construction activities at a distance which conforms to Santa Cruz County regulations.
